**National Register of Historic Places
Registration Form**

historic name *Silver Lake Shipwreck (Scow-schooner)*
other names/site number

Silver Lake Shipwreck (Scow-schooner)
Lake Michigan, Sheboygan County, Wisconsin

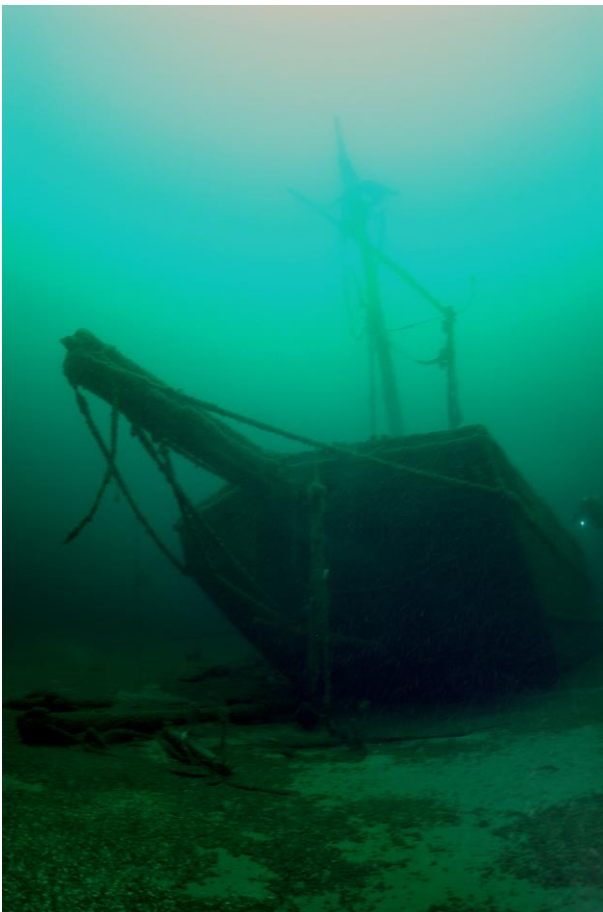
Photo #1 of 1

Silver Lake Shipwreck (Scow-schooner)
Sheboygan County, Wisconsin
Photographer Tamara Thomsen
30 July 2011
View of bow looking aft

The bow features a cross-planked bow ramp that curves upward from the bottom. The stem protrudes from the center of the ramp, and is marked with Roman numeral draft marks carved into the sides of the stem. There is much green paint visible on the bow ramp. Two chain bobstays are fastened to the stem just above the keel. The outer bobstay is intact, but the inner bobstay is broken at the stem and hangs from the underside of the bowsprit and drapes over the stock of the port side anchor. A chain bowsprit guy is extant on either side of the bowsprit. The guys are anchored to the outside of the covering board on either side of the hull on either corner of the bow. The bottom of the double wire forestay is extant, attached to the hull on either side of the bowsprit, but the forestay has parted a few inches above where the two wire forestays are seized together.
